URGENT FIELD SAFETY NOTICE

Regarding **ProteusPLUS** and **ProteusONE**

MID-59393 REV. A

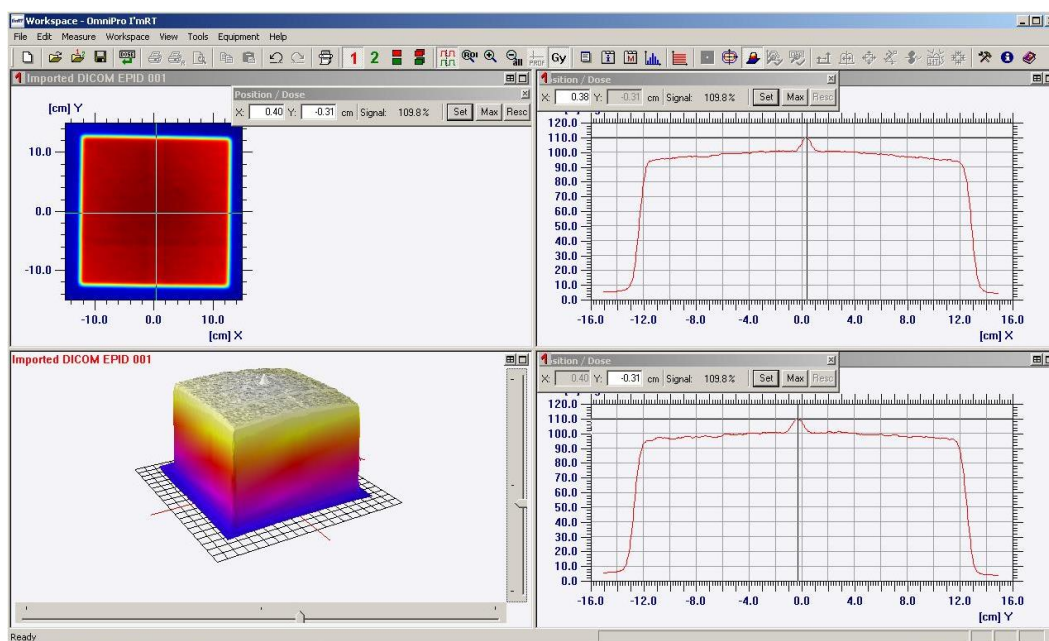
- Run the “Dark Beam” QA Map² with the LYNX dosimetry tool at maximum energy,
- If there is a peak in the center of the beam profile as shown on Figure 1:
 - o Confirm it is due to dark current by running the same QA Map at the lowest energy (if there is no peak, it is most probably due to dark current),
 - o Contact IBA to analyze and fix the issue.

Figure 1 - Peak in the center of a beam profile due to dark current. Here the pick value is 110% of the dose but it could be a higher or lower value depending on the intensity of the dark current.

In case a peak is observed on the beam profile, it is suggested to open a downtime event until the dark current issue is fixed.
