# Urgent Field Safety Notice

Regarding **ProteusPLUS**

GENERAL INFORMATION	
<b>SUBJECT</b>	Potential range effect due to non-conformity of degrader graphite block 8.
<b>IBA REFERENCE</b>	Problem Report PR-58816
INFORMATION ON AFFECTED DEVICE(S)	
<b>PRODUCT</b>	Proteus 235
<b>BRAND NAME</b>	ProteusPLUS
<b>COMPONENT</b>	Beam Management System
<b>SOFTWARE VERSIONS</b>	N/A
<b>MODE</b>	All
<b>SERIAL NUMBER</b>	SAT.115, SAT.116
REASON FOR FIELD SAFETY NOTICE	
<b>DESCRIPTION OF THE PRODUCT PROBLEM</b>	IBA discovered that the holes for the screw inserts to attach the graphite block 8 to the degrader wheel are too deep. See Annex 1 for a schematic description and x-ray image of the non-conformity. As a result of the non-conformity, the beam could go through an air pocket due to the excess depth of the screw hole instead of graphite leading to range errors and the potential mistreatment of a patient. The graphite block 8 is only used for high ranges (see Annex 2 for detailed values).

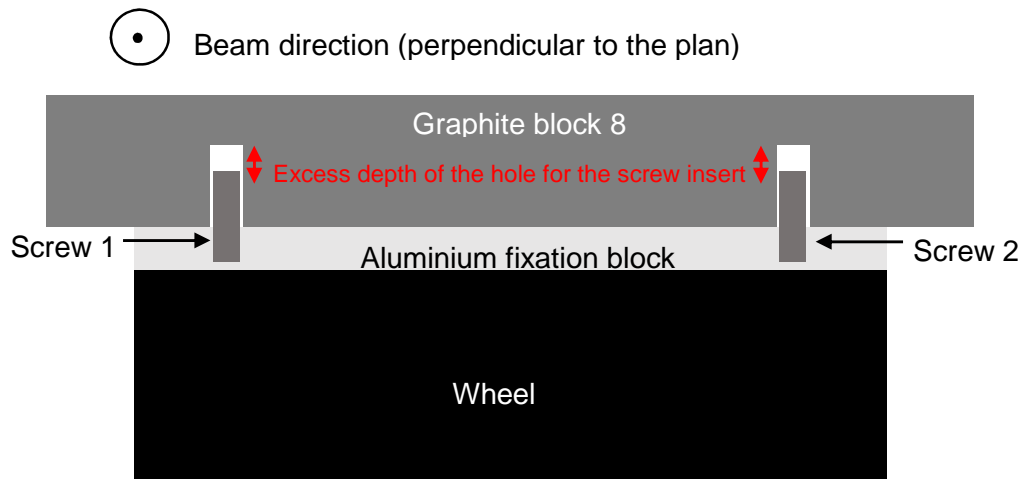
## Annex 1 Graphite block 8 screw holes depth non-conformity

Schematic description of the graphite block 8 screw holes depth non-conformity:

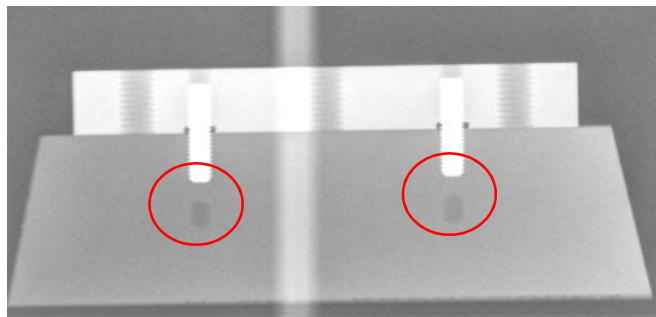
X-ray image of non-conforming degrader graphite block 8:

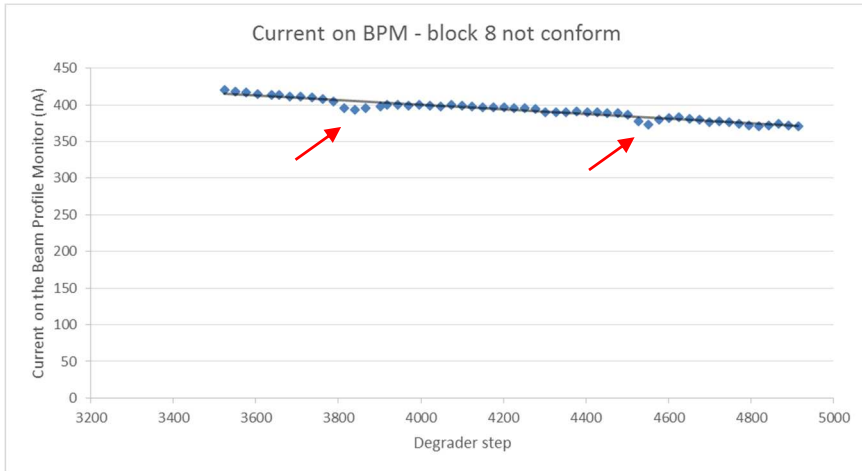
Conformity test	
<b>Tools &amp; Method:</b>	<p>Measure the current after the Energy Selection System on the Beam Profile Monitor using a 25nA Look Up Table and internal pulse generator.</p> <p>Do the measurement between ranges defined in Annex 2 in steps of 0.03cm. Each range corresponds to a degrader step.</p> <p>Create a chart of the Current on the Beam Profile Monitor in function of the degrader step.</p>
<b>Results analysis:</b>	<p>Non-conform block:</p>

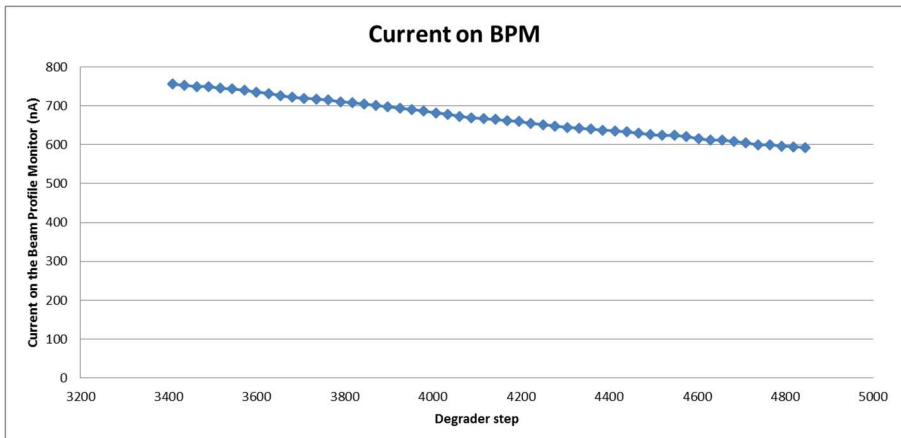
<p>Conform block:</p>
