URGENT - FIELD SAFETY NOTICE

**MAQUET HLX 2004-5 DF, HLX 3004-5 DF and XTEN DF
Field Action MSA/2017/002/IU**

Date: 27 March 2018

Field Correction Notice: MSA/2017/002/IU

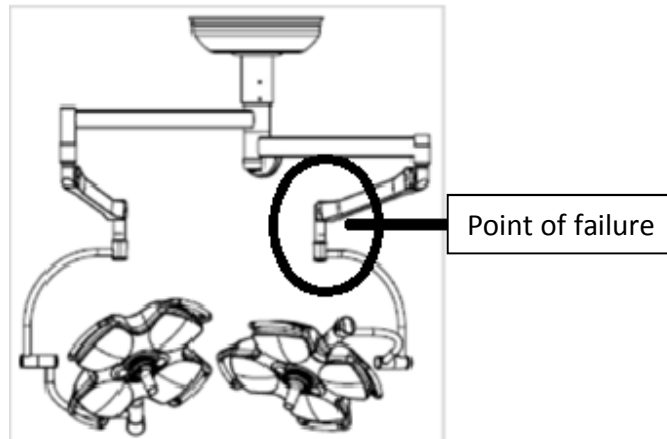
From our investigation it was concluded that there is a low failure rate that only can present itself on the devices of types and production identified in this letter. The issue relates to a crack in the metal of the spring arms that has the potential develop into a break. The devices are over ten years old and even so

This potential for malfunction is caused by fissures near the weld seam at the front pivot of the spring arm. The design of the spring arm was improved in 2006. The devices involved for your market are limited to those listed in the attached Consignee list.

Resolution: MAQUET proposes to replace the affected spring arms with new ones to make sure all devices present in the market are working effectively and safely.

This letter is to inform you of a corrective action that consists of replacing all potentially affected spring arms still in use with new ones. This action will be performed to prevent any possible hazard to persons and equipment.
