TRILUX Medical GmbH & Co. KG · Huettenstrasse 21 · D-59759 Arnsberg

### **Urgent safety information**

#### **Safety information regarding the affected products of the Aurinio L 110, L 120, L 150 and L 160, Aurinio OR lights series**

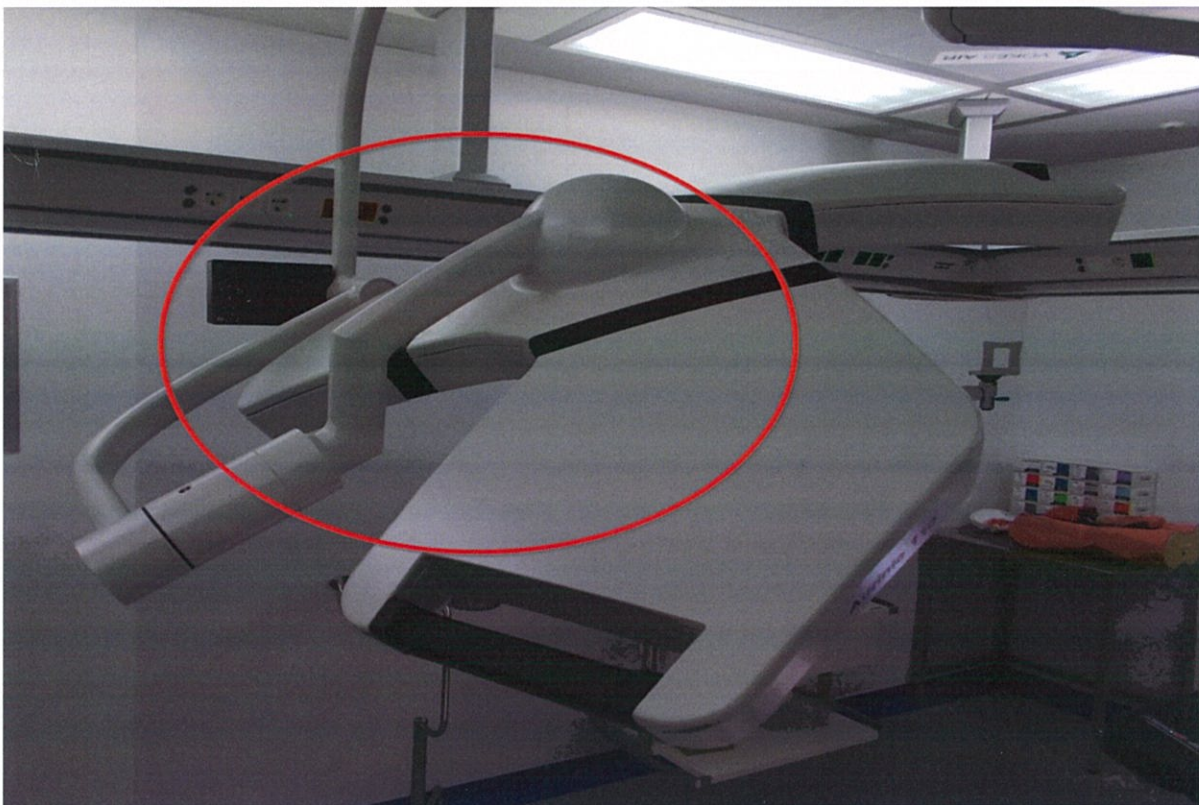
In the context of our worldwide product monitoring, we have determined that a formation of tears can occur in the support structure of the aforementioned lights. This results in a situation where the load-bearing capacity may potentially no longer be ensured and may lead to a material breakage at the welding seam of a component of our OR lights.

Figure 1: Overall system of the Aurinio OR light – affected component marked

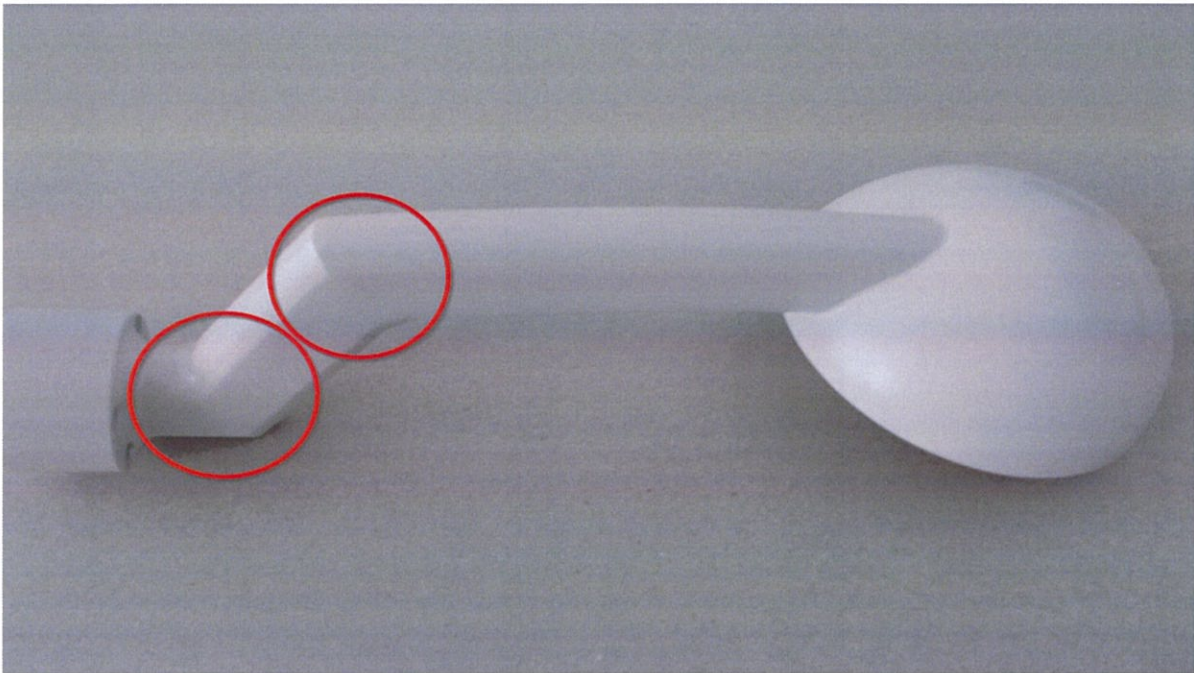
The breakage is preceded by the formation of tears in the construction, see Figure 1-3.

Figure 2: Light's connection – potentially affected areas

Until the corrective measure has been carried out, the affected component (light's connection) of the Aurinio OR light must be subjected to a daily visual inspection for a potential tear formation, in accordance with the marked areas of Figure 2.

In this inspection, please bear in mind that the inspection for the formation of tears must be carried out all around.

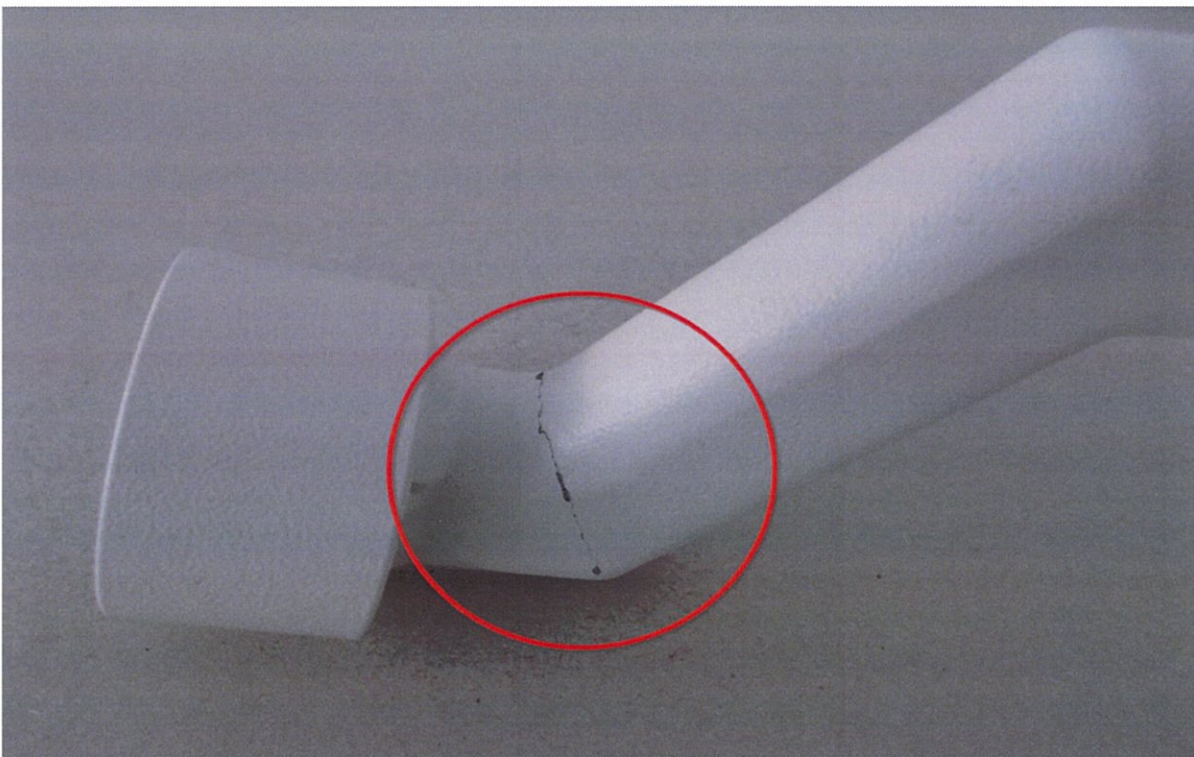
paint on the surface. This can be checked via a visual inspection. The gap that occurs is increasing slowly.

The following figure shows the affected component (light's connection) with the formation of tears to be potentially observed.

Figure 3: Light's connection – tear observable
