URGENT FIELD SAFETY NOTICE

Leica M525 OH4 / Leica M720 OH5 Surgical Microscopes with 400W Illumination

FSCA-Identifier: CAPA-2015-12-001-H

Replacement of cables in illumination unit required

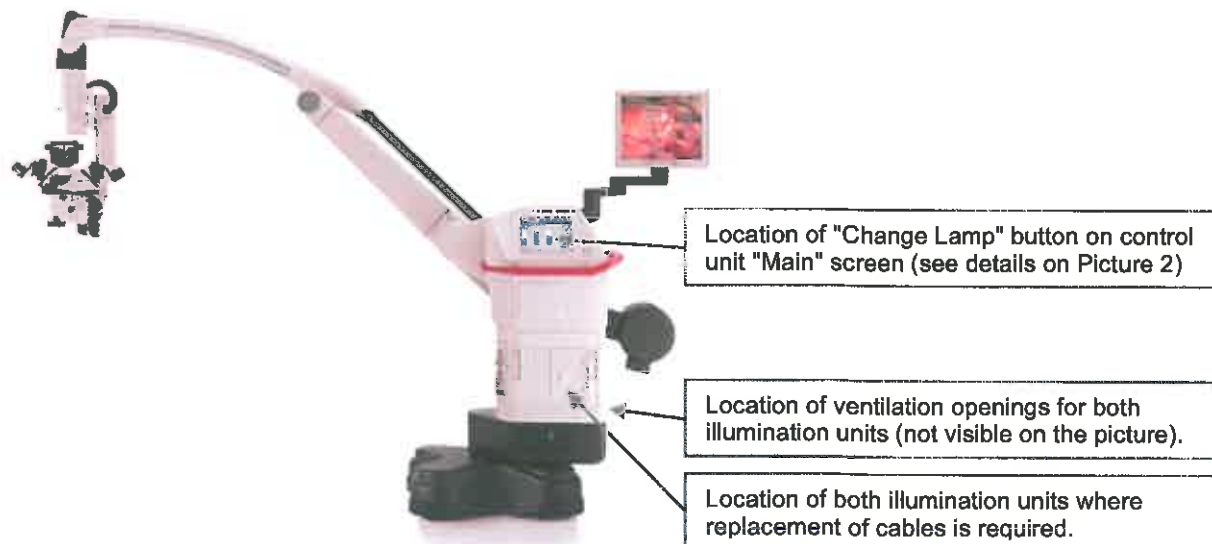
An electronic component in one of the two illumination units can potentially overheat, resulting in minimal smoke and odor emanating from the ventilation openings of the illumination units. The illumination units are located opposite and away from the surgeon / patient side of the surgical microscope (for details see picture 1 below).

In-depth investigation of these reported issues revealed that the root cause is caused by an output filter capacitor in the 400W Xenon Power Supply inside the illumination units. Replacing the power supply output cable of the illumination unit with an improved cable including a filter coil will prevent this failure.

Picture 1: showing a Leica M525 OH4 surgical microscope with marked illumination units, location of ventilation opening for both illumination units and location of the "Change Lamp" button.
This picture is also representative for Leica M720 OH5.

A Leica Microsystems representative will be contacting your facility to arrange the no-cost replacement of the power supply output cables with improved cables including a filter coil in both 400W illumination units of your instrument as soon as possible.

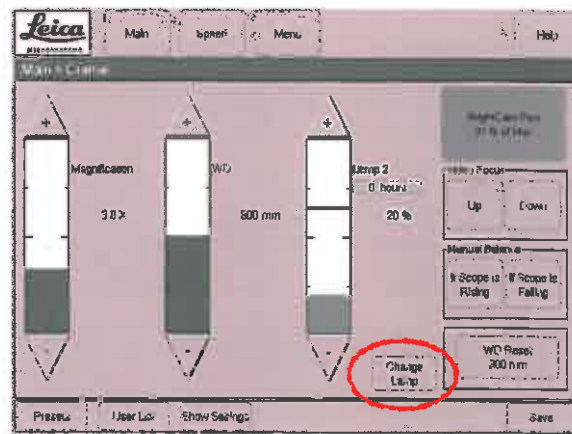
Picture 2: showing the "Main" screen with the "Change Lamp" button marked with a circle.

Independent from the issue explained previously, please be reminded that if you notice a failure in the illumination unit you are currently using, switch to the back-up illumination at the next opportunity during surgery by using the "Change Lamp" button on the control unit "Main" screen (see Picture 2 below) as described in user manual.
