**July-23-2018**

**Urgent Field Safety Notice: EZ1 Advanced XL, REF 9001492**

07/2018 PROM-12614-002

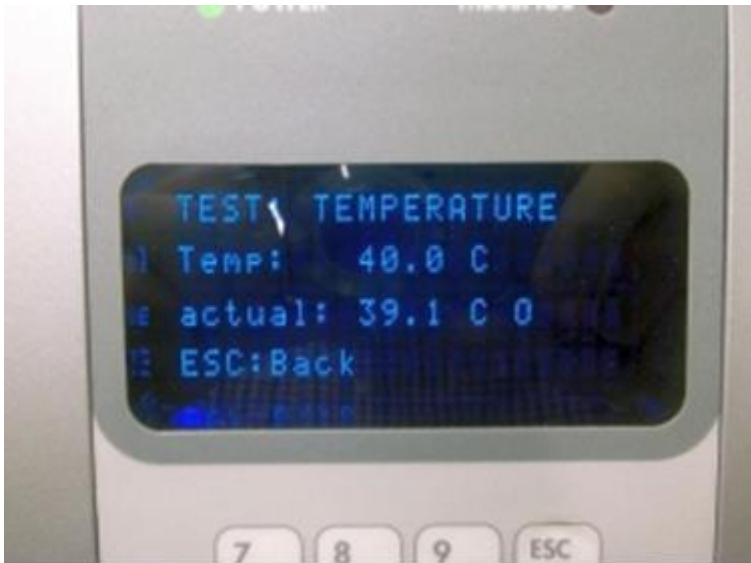
An issue has been discovered regarding the power branching printed circuit board (PCB) within the EZ1 Advanced XL instrument. Occasionally this has the potential to trigger a malfunction of the instrument heater. Nucleic acid extractions processed during failure of the instrument could be compromised and extractions need to be repeated.

Observe the "actual" temperature which is displayed. This should rise to 40.0 C +/- 2 degrees within 2 minutes, and a "O" should be displayed next to the temperature value (Figure 1). In this case your instrument is NOT affected by this issue.

**Figure 1. EZ1 Advanced XL display following a successful temperature check. Note specifically the "O" after the "actual" temperature**

*In the event that the "actual" temperature does not rise to 40.0 C, an "X" continues to be displayed next to the temperature value, indicating that **your instrument is affected by this issue. In this case the nucleic acid eluate from the previous run should be rejected and the sample reprocessed.** Contact technical services to arrange a replacement of the faulty component.*

QIAGEN will proactively replace the faulty component in all potentially affected instruments. Whilst wishing to inform you of this issue as soon as possible, due to limited part availability, replacement may take up to 6 months to complete.
