## URGENT FIELD SAFETY NOTICE

**FSCA identifier:** HV-SAL-2018-001  
**Affected Product:** Perceval Sutureless Heart Valve  
**Type of action:** Advice given by the Manufacturer regarding the use of the device  
**Date:** June 18, 2018  
**Attention:** Implanting Surgeons  
**CC:** Chairman of Medical Board and all relevant Head(s) of Department  
**Reason:** Possibility of stent folding due to Perceval valve oversizing

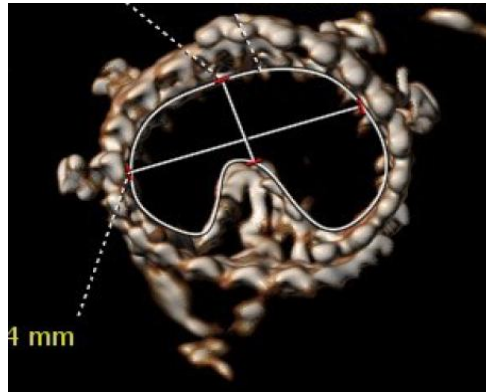
Stent folding is defined as an inward deformation of the stent at the annulus level (see Figure 1).

**Figure 1.** Stent folding

The main root cause identified for stent folding is valve oversizing, associated with other factors such as:

- extremely eccentric aortic annulus;
- highly calcified portion of the annulus, or uneven decalcification (concentrated bulky calcium protrusion);
- aortic root anatomy deviating from the tri-symmetrical physiological geometry (bicuspid valve, or absence of one of the Valsalva sinuses);
- severe hypertrophic septum.

- 1) Decalcification, to avoid uneven surfaces;
- 2) Correct sizing, using available information in the IFU; and
- 3) Ballooning, with the recommendation to pour warm sterile saline (at 37°C) while ballooning.

- 1) Visual inspection, checking that the Perceval stent is correctly deployed; and
- 2) Performing an intraoperative echographic evaluation after Perceval implant to confirm correct positioning and verify valve functionality under beating heart conditions.
