August 2018

URGENT PRODUCT CORRECTION NOTIFICATION
Potential for Unsuppressed Results using VITROS® 5600 Integrated Systems

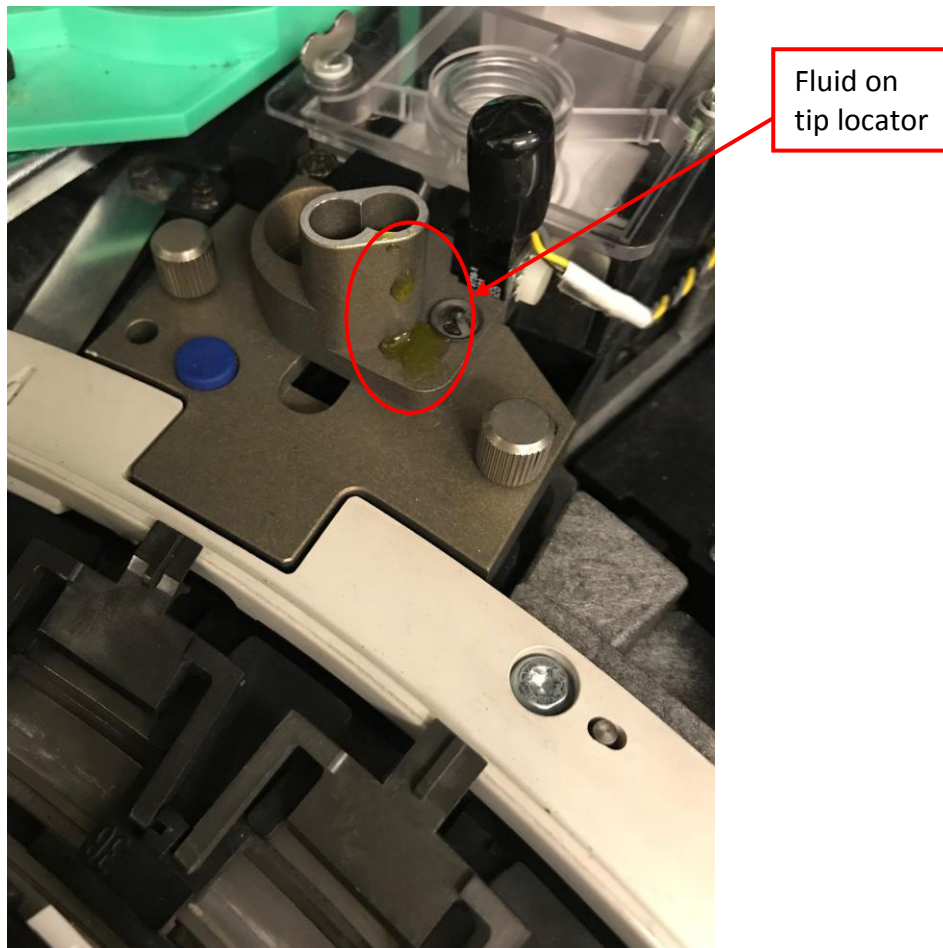
If these specific circumstances occur, the proboscis may deposit fluid on the tip locator or top surface of the slide and transfer sample fluid into the incubator.

- Sample fluid is observed on the tip locator and/or
- Increased number of results with an out of range (OR) code or results outside of your supplementary range (SR) for a same sample and/or
- Multiple Metering dispense pressure codes occur on the same sample resulting in a Drop Error "DE" code.

The photograph below shows an example of fluid on the tip locator:

- If you observe unexpected MicroSlide assay results for a sample associated with TE1-504 and/or TE1-594 condition codes, please do the following:
 - Inspect the tip locator to determine if sample fluid is present. Refer to example shown on page three.
 - If fluid is NOT observed, repeat all MicroSlide assays for the affected sample.
 - If sample fluid is observed on the tip locator or repeated results do not agree (i.e., incorrect results), contact your local Ortho representative or our Ortho Care™ Technical Solutions Centre for further assistance.
- Complete the Confirmation of Receipt form no later than August 24, 2018.
- Post this notification by each VITROS 5600 System in your facility or with the user documentation.
