## **BiPAP A40 affecting Detachable Battery Module**

### **Incorrect Side Panel**

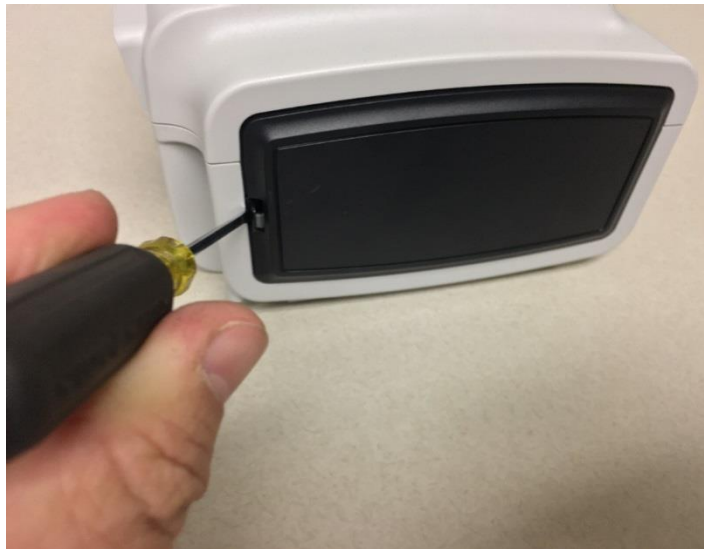
1. Remove the Left Side Beauty Cover. Gently depress the tab securing the Left Side Beauty Cover in place. A small flat head screwdriver may be used to aid in depressing the tab if needed.

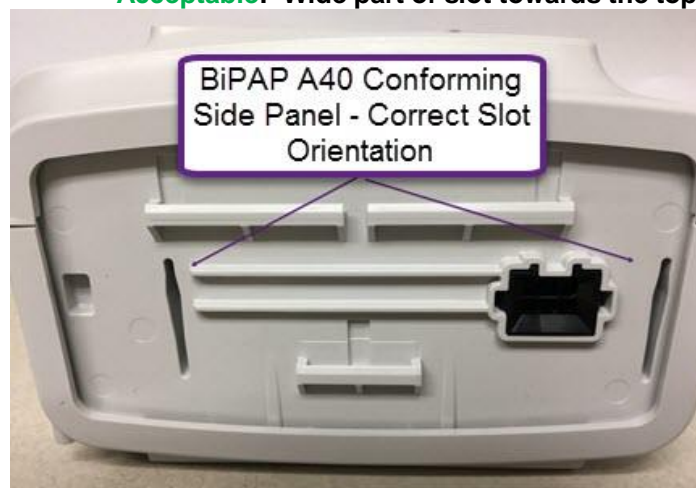
2. Inspect the slots in the Left Side Panel for the correct orientation.
3. If inspection confirms both slots are in the correct orientation with the widest portion towards the TOP of the device, no return is required. Refer to Figure A.

**Figure A**  
**Acceptable: Wide part of slot towards the top**

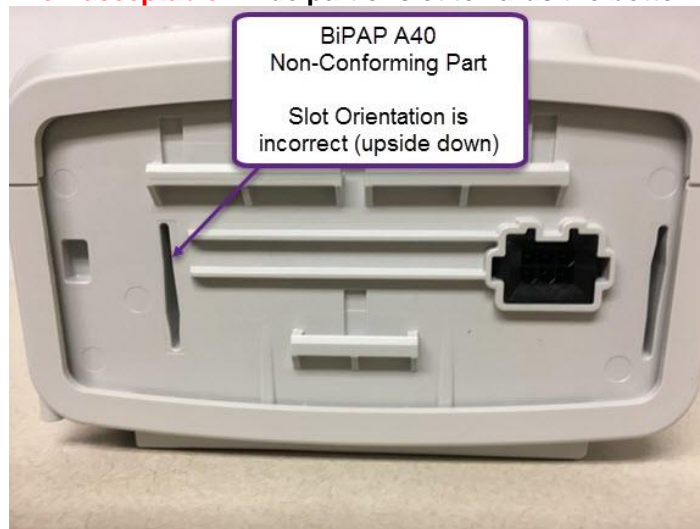
4. If inspection confirms either of the slots are in the incorrect orientation with the widest portion towards the BOTTOM of the device, ***return is required for replacement*** of the Left Side Panel. Refer to Figure B.

**Figure B****Non-acceptable: Wide part of slot towards the bottom**

<b>ACTIONS PLANNED BY PHILIPS</b>	Philips will coordinate replacement of the non-conforming side panel for all affected equipment identified in the returned Business Reply Form. Philips will issue a no charge order to replace the affected device side panel.
<b>FURTHER INFORMATION AND SUPPORT</b>	If you need any further information or support concerning this issue, please contact Philips Respironics Customer Service by phone for assistance
