Field Safety Notice

HeartMate 3[™] Left Ventricular Assist System Catalog # 106524INT – HM3 LVAS KIT

April 5th, 2018

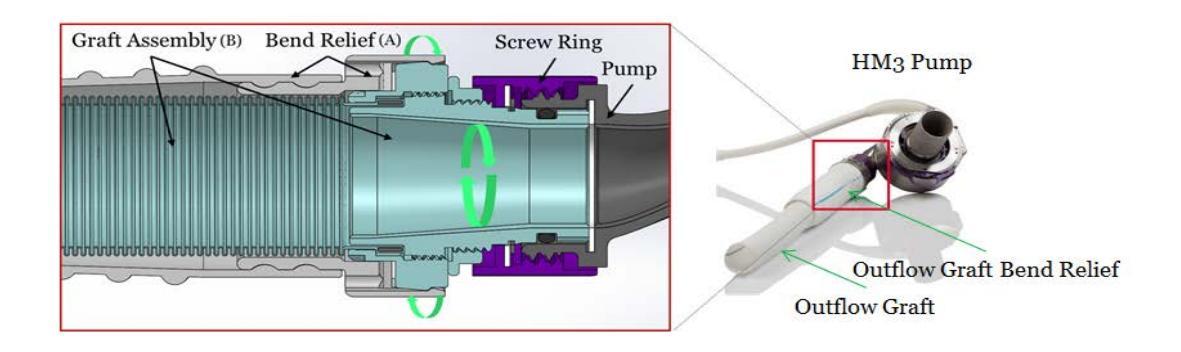
The Outflow Graft is the conduit for blood flow from the HM3 pump to the ascending Aorta.

Normal *in vivo* forces associated with heart beats, respiration and patient activity can cause small rotations between the Outflow Graft Bend Relief (A) and the pump. These rotations are expected and appear to be 'back and forth' without accumulation in either direction. However, there is the potential for these forces to be preferentially translated to the outflow graft (B) in either the 'back' or 'forth' direction which may deform the outflow graft and reduce pump flow. The accumulation of outflow graft twist can occur at any point beyond implant. Postoperative twisting and occlusion of the HM3 outflow graft may result in the need for surgical intervention following the original implant procedure.

- During implant, when attaching the Outflow Graft to the Pump Cover, a clicking sound will be heard as the Screw Ring is tightened. Continue turning the Screw Ring clockwise until it comes to a complete stop and stops clicking for a firm hand tightened connection.
- If a low flow alarm persists at any time following implant, and other potential causes such as hypertension, low preload, right-heart failure and inflow occlusion have been considered for cause, a Computed Tomography (CT) angiography should be taken to identify the possibility of an outflow graft twist occlusion.
- In the event surgical repair of the outflow graft is needed due to a twist occlusion, the Outflow Graft Bend Relief should be reattached in its original state or repaired to prevent further kinking or occlusion of the graft.
