FSCA-PMJ-16-02-1

MEDICAL DEVICE FIELD SAFETY CORRECTION

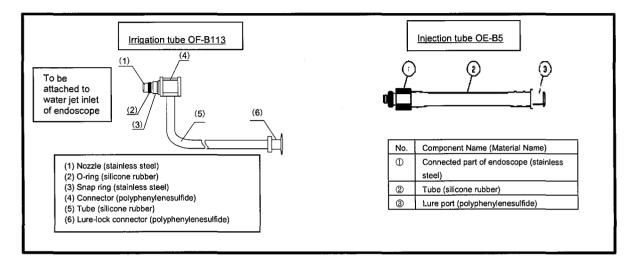
Contact information:
