Urgent FIELD SAFETY NOTICE: Perifix Catheter Connector

On behalf of B. Braun Melsungen AG, we have decided to proactively inform our customers in the context of a voluntary FIELD SAFETY NOTICE on a problem with the **Perifix Catheter Connector**.

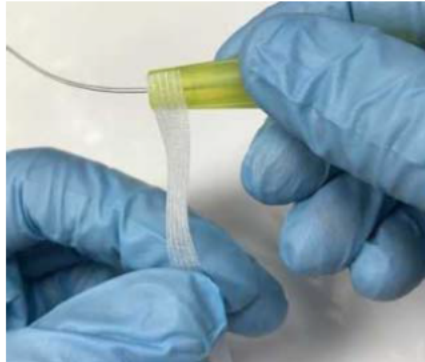
Figure 1

- 1) Place the catheter according to internal hygiene policies.
- 2) Connect catheter and verify catheter placement per product instructions.
- 3) Fix the catheter.
- 4) Take an adhesive tape available in the hospital.
- 5) Begin wrapping the tape around the catheter connector starting from the bottom of the distal end.

- In case you encounter any of the described issues we recommend to secure the catheter with adhesive tape as described in Appendix 1.
- Confirm receipt of this information by completing the attached confirmation slip and return this to B. Braun using the contact details provided.

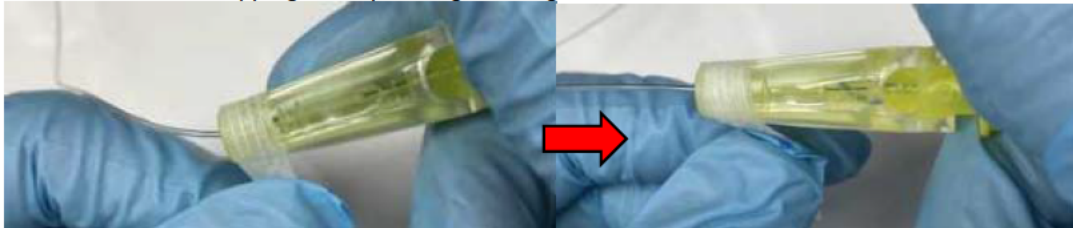
Figure 2

- 6) Continue wrapping the tape along the length of the connector.

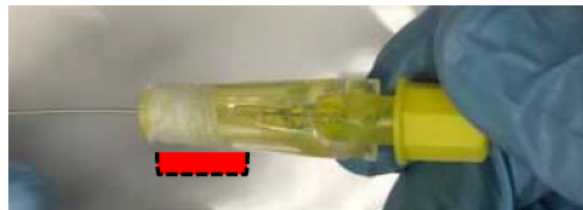
Figure 4

- 7) To maintain secure closure of the Catheter Connector, the tape should cover approximately 1/3 of the length of the connector.
