Urgent Field Safety Notice DI-16-01.A.OUS

Dimension® Integrated Chemistry Systems

<u>ELECTRICAL HAZARD WARNING:</u> Dimension RMS Compressor Assembly Protective Electrical Cover Missing

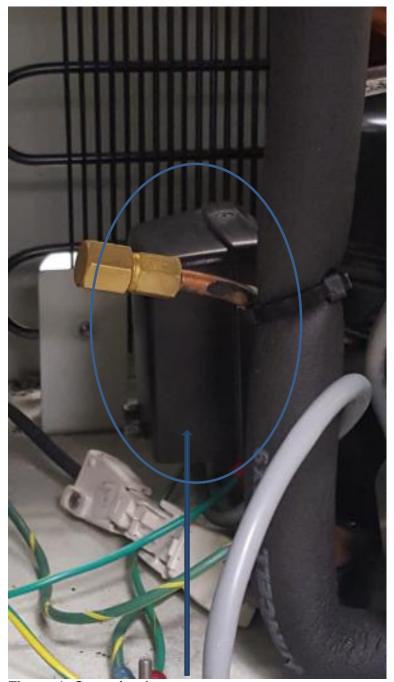
Figure 1. Cover in place

1. Refer to Figures 1 and 2.

- 2. Use caution when removing the RMS Waste Container. **DO NOT REACH HANDS INTO RMS CABINET BEYOND REMOVING THE WASTE CONTAINER. IF ANY FLEX CARTRIDGE FALLS OUTSIDE THE WASTE CONTAINER DO NOT REACH INSIDE THE RMS CABINET TO RETRIEVE IT.**
- 3. Securely attach the WARNING page within this Urgent Field Safety Notice on the outside of each RMS cabinet door as a temporary WARNING for all operators.
- 4. Return completed Field Correction Effectiveness form to Siemens Healthcare Diagnostics as instructed in the last page of this Notice.

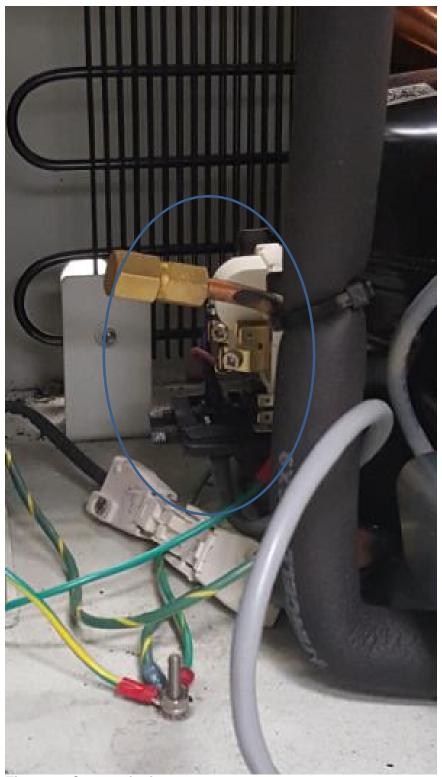
Siemens Healthcare Diagnostics is notifying you of a potential safety issue regarding the Dimension Reagent Management System (RMS) refrigeration compressor. Siemens has identified RMS refrigeration compressors that are missing the safety cover on the electrical termination block. The exposed electrical hazard on the electrical termination block is located directly behind the RMS Waste Container.

The absence of the safety cover results in a potential electrical hazard to the operator. This issue does not impact patient results.

Figure 2. Cover missing

Your Siemens Customer Service Engineer will contact you to schedule a visit to inspect your RMS refrigeration compressor.

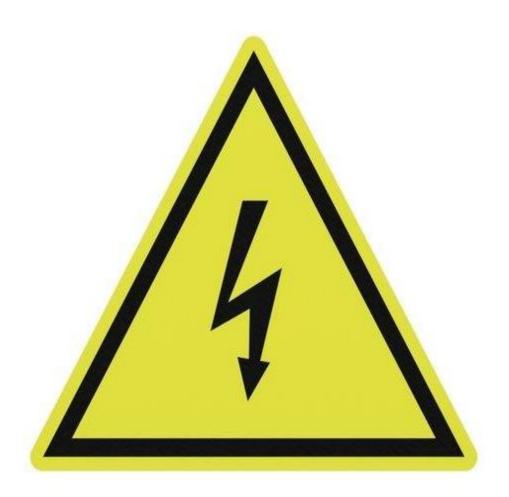
WARNING

ELECTRICAL HAZARD TO THE OPERATOR

DO NOT TOUCH the electrical termination block on the refrigeration compressor within the Reagent Management System (RMS). If any flex cartridge falls outside the waste container DO NOT reach into the RMS cabinet to retrieve it.
