**ADVIA® 1200 Chemistry Systems**  
**ADVIA® 1800 Chemistry Systems**  
**ADVIA® 2400 Chemistry Systems**

#### Potential for Halogen Lamp Premature Failure (SMN 10309448)

### Potential for Halogen Lamp Premature Failure

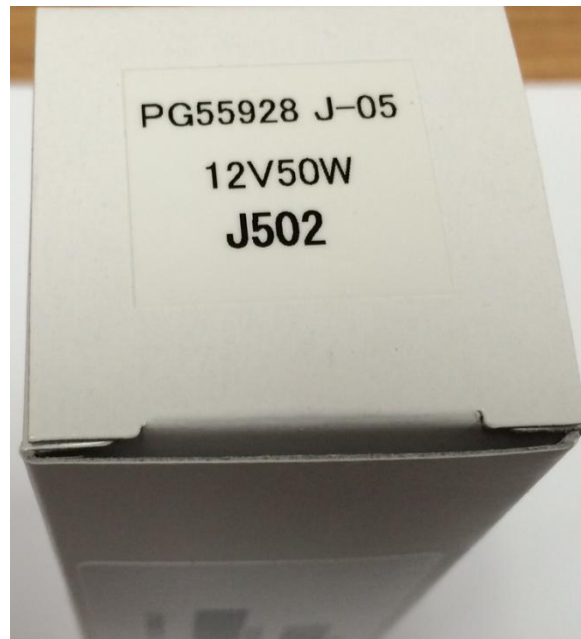
Figure 1 – Identifying the Halogen Lamp Lot Number on the Lamp Packaging

- Please check your inventory for affected lots, see Fig 1 and 2 for the location of lot information on the packaging and product, respectively.
  - Note: If your current inventory includes any lamps from the affected lot numbers that have a green dot on the packaging (see Fig. 3) and a cut corner on the wire lead lot label (see Fig. 4), this notification does not apply. These markings denote that the lamp has been tested for performance by the manufacturer.

- If one or more lamps from the affected lots are currently in your inventory and do not comply with the above note, please discard the lamp and please follow the instructions on page 5 to request a replacement.

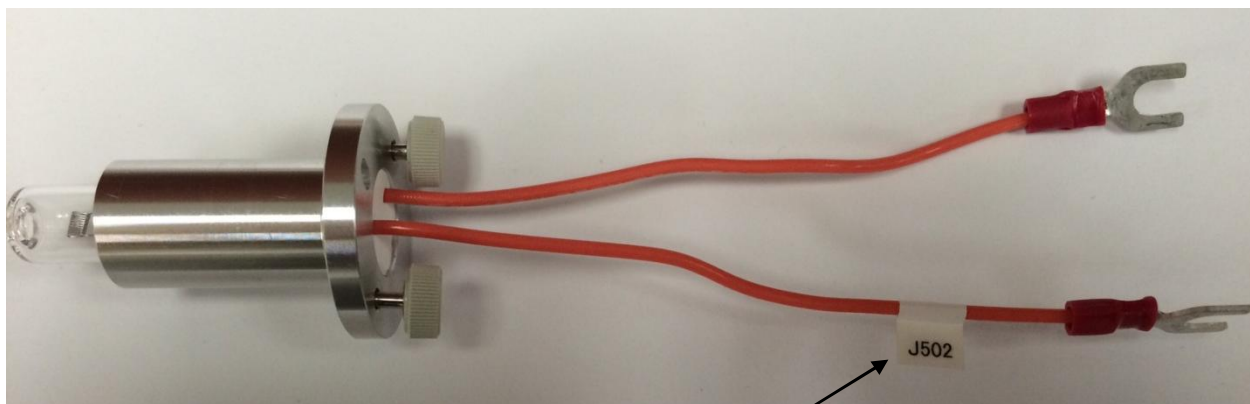
Figure 2 – Identifying the Halogen Lamp Lot Number on the Lamp's Wire Lead

Lot number identification tag on the  
Lamp's wire Lead.

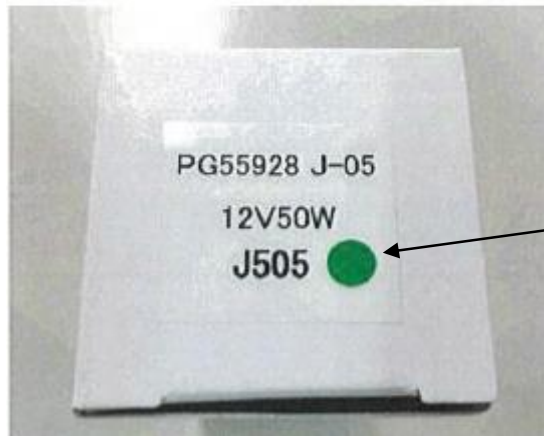
Figure 3 – Identifying Lamp Packaging Tested by Manufacturer

A green dot on the packaging indicates the lamp was tested by the Manufacturer.

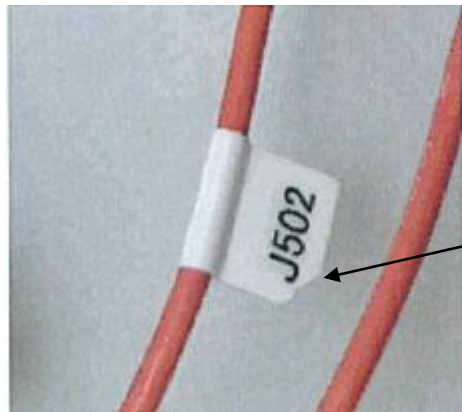
Figure 4 – Identifying Tested Halogen Lamp Lot Number on the Lamp's Wire Lead

Lamps that were tested by the Manufacturer have a corner cut off of the Lot Number Tag on the Lamp's Wire Lead.
