Filed safety notice to ripcords for treadmills built in 2014/2015

Users and operators of h/p/cosmos treadmills built in 2014/2015

All h/p/cosmos treadmills built in 2014 and 2015 equipped with a ripcord, clip and magnetic switch:

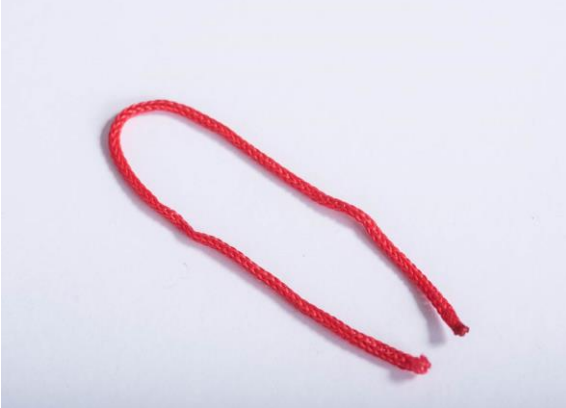
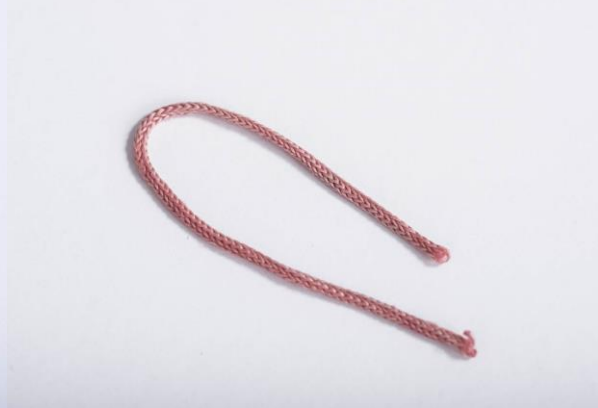
For the above-mentioned model series built in 2014 and 2015 it is possible, that in exceptional cases, the red cord between the magnet and the clip may not maintain the required tensile strength. This premature aging is probably caused by intense sunlight (UV radiation).

Immaculate condition: full red color	Material fatigue: discoloration from red to faded or white

1. Please make a visually and functional control of the ripcord including clip and magnetic switch.
2. The cord must have a full red color and must not show any cracks or damages.
3. Apply a tensile load of about 1 kg (10 N) at the clip. The cord must pull the magnet off the magnetic switch. The treadmill has to stop.
4. If the color fades this indicates premature aging due to external influences. The same applies for any cracks or other obvious damages of tissue.

From January 1, 2016 the red cord shall be replaced annually during the preventive maintenance and safety check service as recommended by the manufacturer.

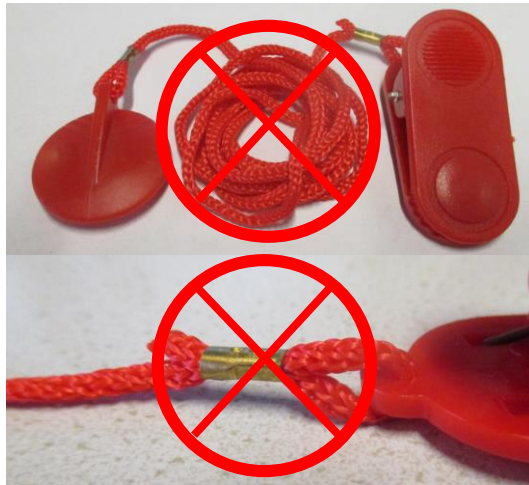
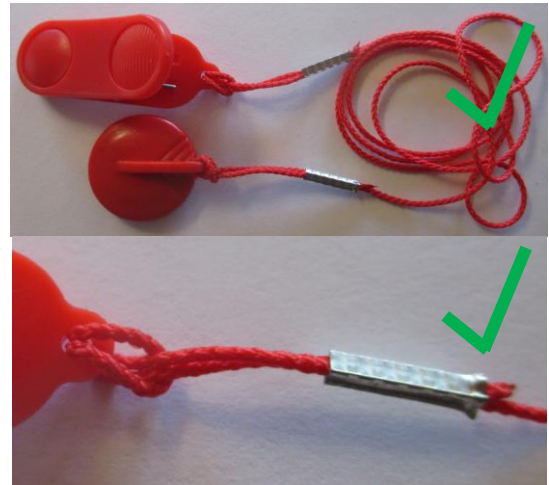
Since December 1, 2015 all affected treadmill models are equipped with a changed ripcord (article number cos101699-03), which has an increased protection against UV light and chemical influences (e.g. through aggressive cleaning agents or disinfectants).

old

new
