URGENT: FIELD SAFETY NOTICE

Commercial Name of Affected Product: LX3 Microscope Floor Stand
Reference(s): 8065752560
FSCA Identifier: 2017.041-ITC
Type of Action: Voluntary Medical Device Correction

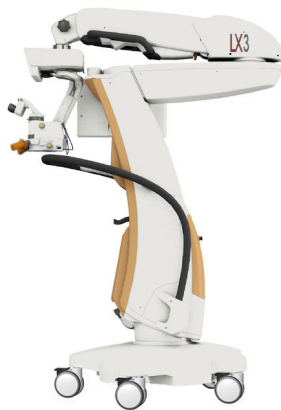
During in-facility transfer, should a caster break or detach from the base while the microscope arm is not in the most inward locked position (as shown in Figure 1), the unit may tip if the microscope arm is extended (as shown in Figure 2) over the location of the broken caster. This may lead to the potential for physical injury from the microscope tipping or falling. Two incidents of physical injury have been reported in conjunction with this issue.

Figure 1
Articulating microscope arm
in stowed and locked position

During in-facility transfer, please ensure the articulating microscope arm is placed in a stowed and locked position over the microscope base (as shown in Figure 1) and protect the casters from forceful impact. This will distribute the LuxOR / LX3 unit weight evenly amongst all of the casters to reduce the potential for the units to tip or fall in the event that a caster breaks. If you need to transport your unit to an off-site location such as a different building or have immediate concerns about your unit, please contact your Alcon technical representative for professional support.

1. During in-facility transfer, please ensure the articulating microscope arm is placed in a stowed and locked position over the microscope base (as shown in Figure 1 above) and protect casters from forceful impact during transfer..
2. Forward this information immediately to all departments within your organization who may be using the LX3 Microscope Floor Stand unit.
3. Provide a copy of this notification to any other organization / location to which the LuxOR / LX3 has been transported.
4. Return the attached Response Form via fax or email to Alcon.

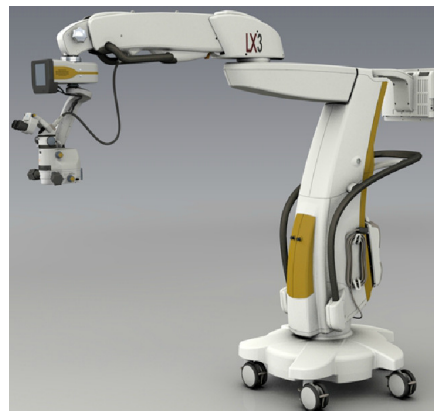
Alcon has observed that multiple shipments or forceful impact to a caster on a LuxOR/LX3 microscope may stress the microscope base, which could contribute to a caster breaking or detaching from the base.

Figure 2
Articulating microscope
arm in extended position

As a precaution, we are voluntarily inspecting and retrofitting LuxOR / LX3 units with new bases and / or an updated caster configuration.

Our records indicate you have a LuxOR / LX3 unit within your facility. Alcon will contact you to schedule an appointment for one of our Field Service Engineers to inspect and replace your unit's base and / or provide an update of the caster configuration, at your convenience.
