PRODUCT ADVISORY NOTICE

Date: August 5, 2016
Subject Device: Exactech GPS Station v2
Attention: Exactech GPS Users

Advisory Notice

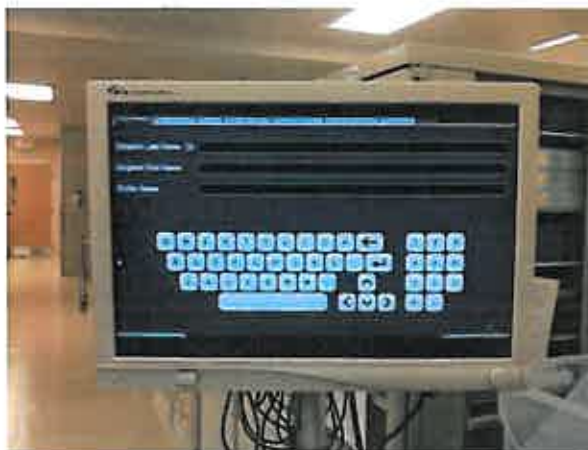
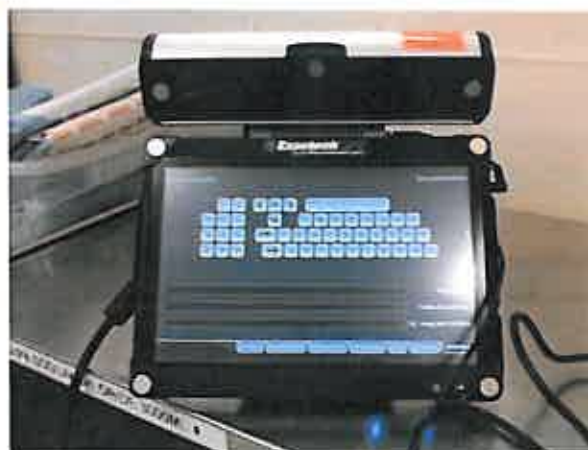
When connecting the Exactech GPS Stations v2 to an external display, it causes issues with the system display resolution and orientation leading to a screen rotation of the main unit.

The issue was detected in the Operating Room, as described on the pictures hereafter:

The issue is due to a wrong software configuration set up during the manufacturing of the Exactech GPS Stations v2.

A software patch has been developed and Blue Ortho has initiated its deployment on the field.

A servicing procedure has been issued and should be applied by authorized staff on all Exactech GPS Stations v2 impacted.

BLUE ORTHO recommends to not use the secondary screen functionality until the issue is solved. If this is not acceptable, ship back the Exactech GPS Stations v2 to your Exactech local correspondent.
