IMPORTANT FIELD SAFETY NOTICE

CentriMag™ Acute Circulatory Support System Motor Model: 201-10002
Compatible with CentriMag™ Pump and PediVas™ Pump

September 5, 2018

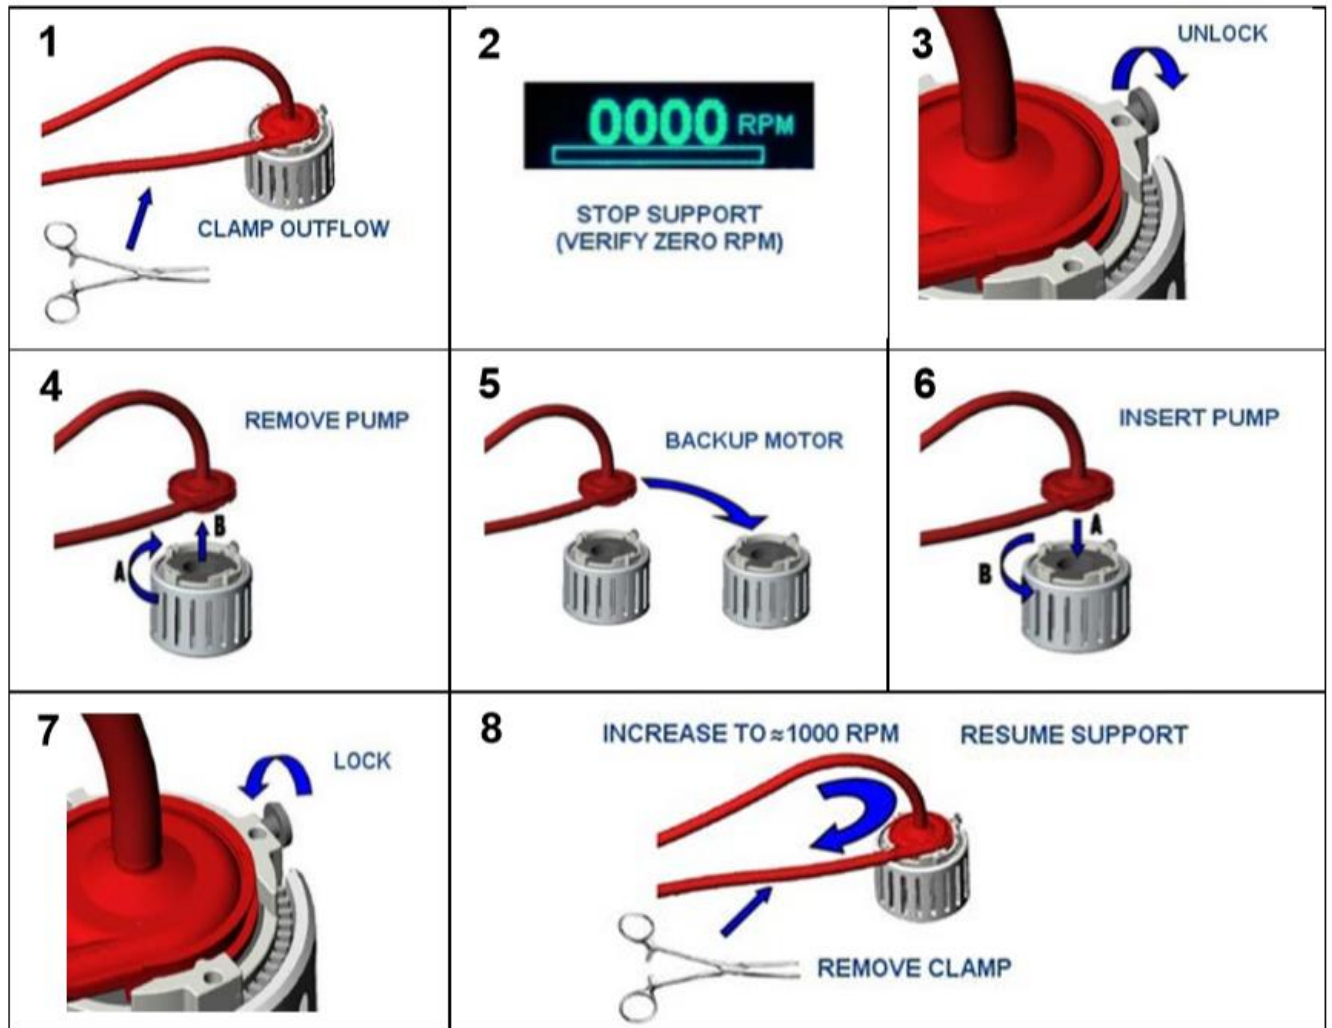
Appendix 2: Existing Blood Pump Exchange Instructions

- Graphic regarding cable handling in the relevant CentriMag Circulatory Support System Operating Manual demonstrating the proper steps from transitioning a pump between the primary and backup systems.

- A full backup system must be in the immediate vicinity of every patient supported by the CentriMag System.
- Exchange the pump to the backup system as described in the CentriMag System Operating Manual and in Appendix 2. Improperly exchanging the motor to a backup console only could cause damage.
- Inspection of the CentriMag Motor, including the cable, for damage should be conducted prior to use. Do not use if damaged. If the cable is damaged and not visible as part of the inspection, the console will alarm during the procedure. Further detail about the visual inspection can be found in Appendix 3.
