Medtronic International, Ltd. (Singapore Branch)

URGENT: MEDICAL DEVICE CORRECTION O-arm™ 1000 Imaging System BI-700-00027-XXX and BI-700-00028-XXX

22nd May 2019

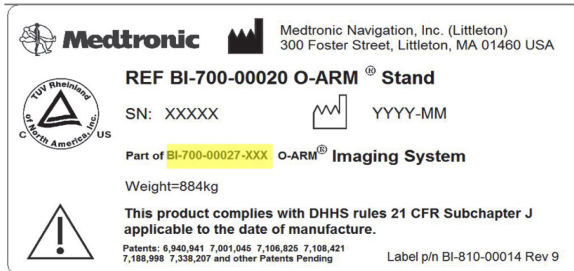
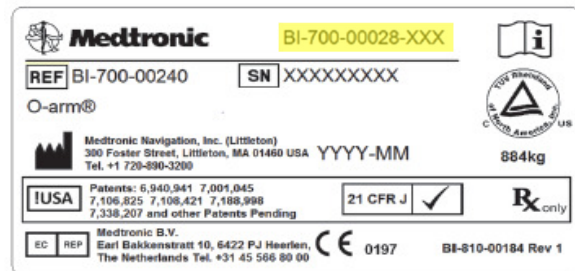
IAS Label

You may view the product labels on the Image Acquisition System (IAS) or the Mobile View Station (MVS), as indicated in the locations noted below, to confirm if the product is labeled with the product numbers BI-700-00027 or BI-700-00028 (highlighted in yellow) and is in scope of this correction.

Located on rear cabinet of IAS

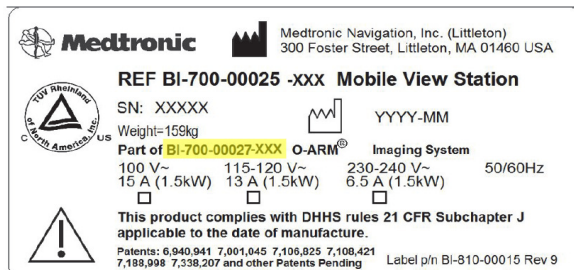
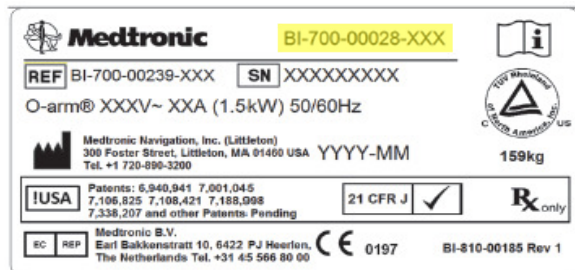
MVS Label

Located on bottom of panel on rear of MVS
