URGENT - Field Safety Notice

Philips IntelliVue Information Center iX (revision A.XX (where XX is 00 to 02) option LAB, PIIC iX revision B.00 option LAB and PIIC iX revision B.0 Enterprise Server (option LAB is bundled)):

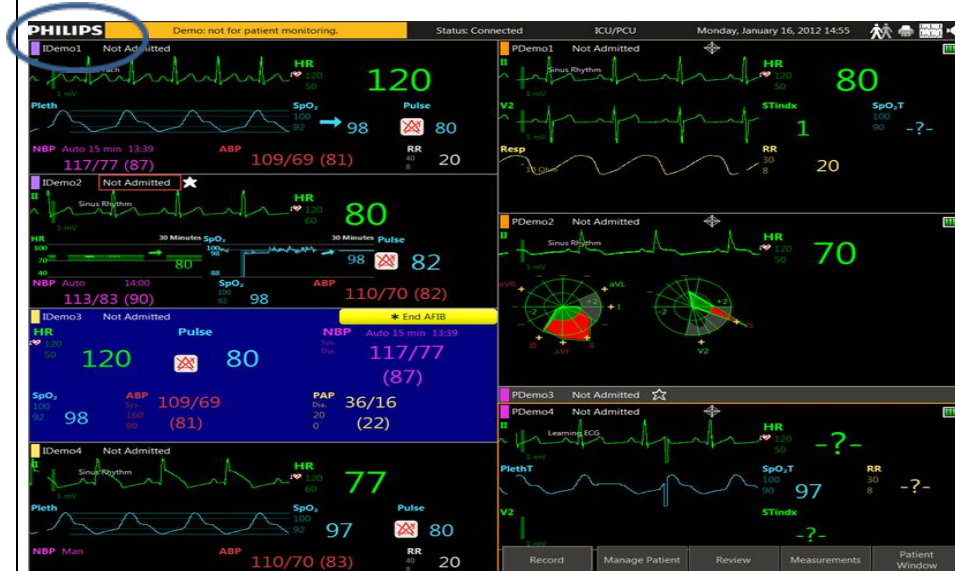
PIIC iX Revision – Identify the affected product by clicking on the Philips watermark on the PIIC iX surveillance display. This will bring up the Product Support Page.

This screen shows the licensed features that have been included. All affected units will show the option LAB active in the License Information.
