Ambu2015FA0001

## **Urgent Field Safety Notice**

**Ambu AuraGain**

**December 10, 2015**

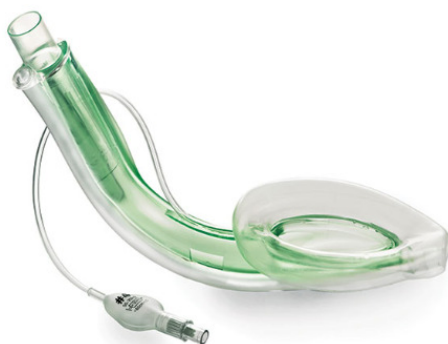
A failure has been discovered during routine quality control at the manufacturing site. This failure may cause a small hole (approximately 0,5 mm) in the pouch of the device leading to a potential compromised sterile barrier. A leak in the sterile barrier may allow contamination of the device with the risk of causing an infection, which may require antibiotic treatment.

The cause of the potentially compromised sterile barrier is a small hole in the transparent film. Please see picture to the right, for a visual specification of the area to inspect.

B: Place your AuraGain devices of the affected LOTs in quarantine, for collection and replacement by Ambu.
