CIL 88200496 Rev01

Philips BrightView, BrightView X, BrightView XCT, and BrightView XCT Upgrade

Version 1.2.3 (and higher) and 2.5.3 (and higher) Software Upgrade Issues

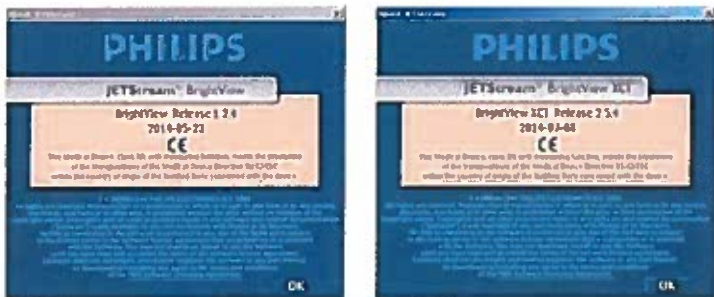
. This is the BrightView JETStream icon. 2. Select Help > About JETStream to view the splash screen information. For example, software version 1.2.4 or 2.5.4 <div data-bbox="581 1018 1291 1312">
