**URGENT - Medical Device Recall
IntelliVue MX40**

<Date> **Increased Battery Power Consumption and Absence of Low Battery Alerts**

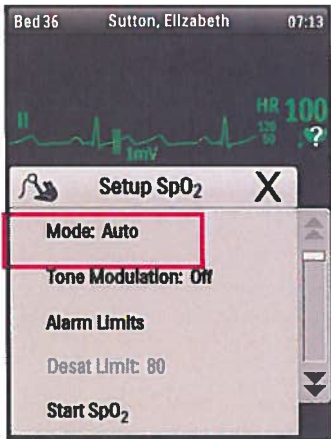
<p>Problem 2 / Step 3 Confirm that MX40 includes SpO₂ operating in automatic mode</p>
