FSN 72800693_72800698 Revision: 01

URGENT - Field Safety Notice Medical Device Correction

Brilliance iCT, Brilliance 64, Ingenuity Core, Ingenuity Core 128

Fastener Replacement

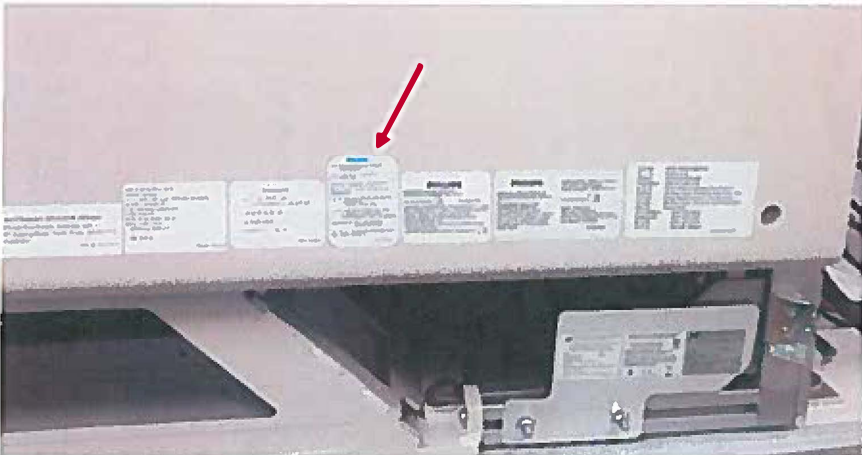
<p>Serial Number labels are located on the back of the gantry in the bottom right corner:</p>
