URGENT MEDICAL DEVICE CORRECTION

GEHC Ref# 34079

RE: Avance CS², Avance, and Amingo System Malfunction when Lower Drawer Closed Forcefully

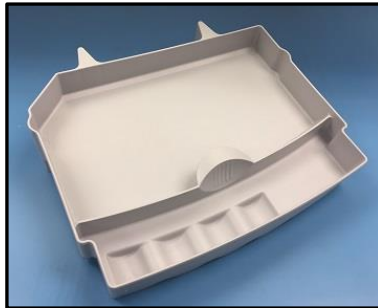
PIC01 – 1009-3260-000 Large Tray Insert

GE Healthcare has become aware of a potential safety issue where certain Avance CS², Avance and Amingo anesthesia devices can transition to a System Malfunction state if the lower storage drawer containing the optional large tray insert accessory (see PIC01 below), is closed with an abnormally high amount of force.

Avance CS2, Avance, and Amingo anesthesia devices with the optional large tray insert accessory installed (part number 1009-3260-000) are susceptible to the issue. The large tray insert accessory can also be used with the Aespire family of devices, however, the Aespire devices are not susceptible to this issue. The optional small tray insert does not produce this issue.

You can continue to use your Avance CS², Avance, and Amingo devices after removing the optional large tray insert accessory, if installed.

The optional large tray insert accessory can be removed from the device manually by any clinical user or site authorized personnel. No tools are required and no technical training is necessary to remove the large tray insert.

GE Healthcare requests that clinical users receiving this device correction notice destroy all large tray inserts in their possession.
