**AMENDED –  
URGENT MEDICAL DEVICE RECALL**

GEHC Ref# 32067-A

RE: Giraffe Warmer/Panda iRes Warmer - Bedside panels or latch areas may be cracked, broken, or damaged.

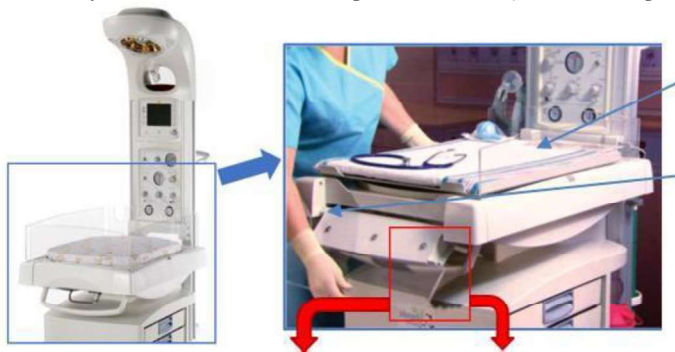
Figure 1A: Bedside panels

Figure 1B: Area connecting panel to bed

**BEFORE EACH USE OF THE DOOR PANEL:** Visually inspect for any cracks or damage to the bedside panels, the latch area, and the area connecting the panel to the bed (see below Figure 1B). If any portion of the bedside panels or latches is damaged or cracked (see below Figure 1C), **stop use of the warmer**.

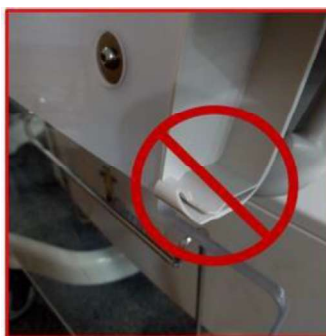
Figure 1C - Broken Latch

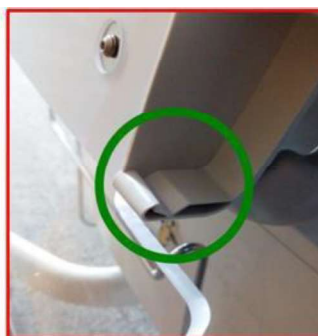
Figure 1D - Good Latch

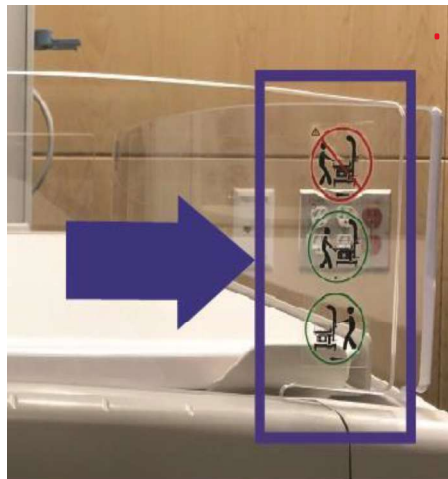
1. Make sure all procedures in the initial recall (FMI32067 Revision 2 Addendum) are complete. Warmers with that FMI applied will have the labels shown below on the 3 bedside panels.

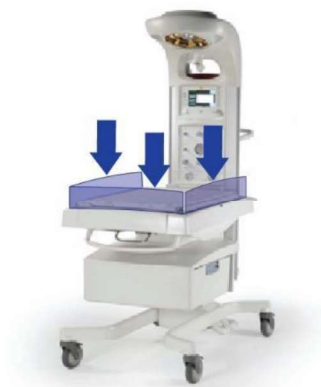
Each warmer has 4 bedside panels. Do the procedure listed below for each of the 3 movable bedside panels. One label must be applied to each bedside panel.

**Note:** A Panda warmer is shown above. Giraffe iRes warmers have higher bedside panels, but the labels are applied in the same locations, as shown by the blue arrows above and specified below.

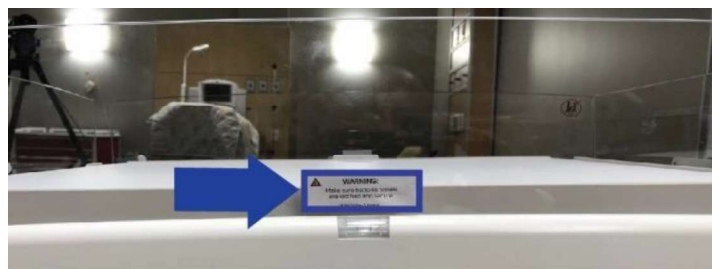
**Side bedside panels:** Attach the label .25 inches (6 mm) above the level window at the bottom of both side panels.

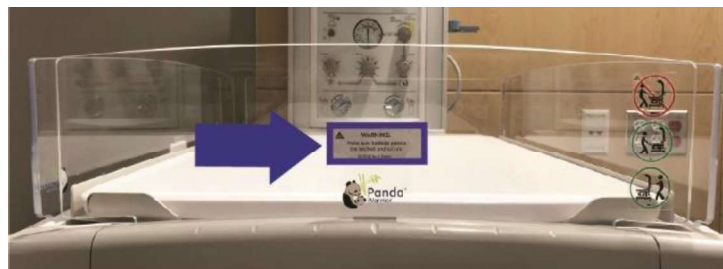
**End bedside panel:** Attach the label 0.25 inches (6 mm) above the logo sticker.
