## URGENT FIELD SAFETY NOTIFICATION

### RE: Stryker 2-Stage and 3-Stage I.V. Poles

**FSCA identifier:** Product Field Action RA2015-014

**Type of Action:** Field replacement

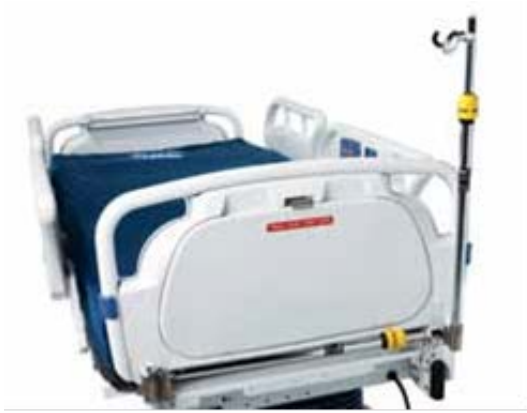
Figure 1. S3 Hospital bed with 2-Stage I.V. Pole

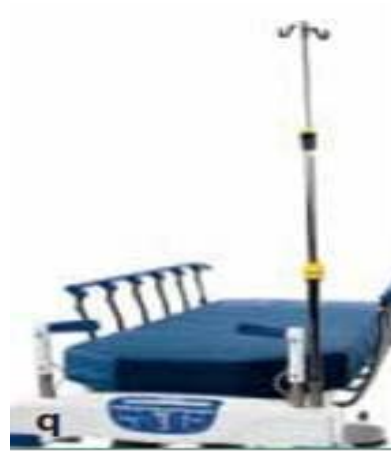
Figure 2. Prime Zoom Stretcher with 3-Stage I.V. Pole
