## **URGENT - Field Safety Notification Medical Device Correction**

### **Philips HeartStart MRx Monitor/Defibrillator on exceptionally rare occasions may exhibit abnormal behavior when operating using a single battery as the sole source of power.**

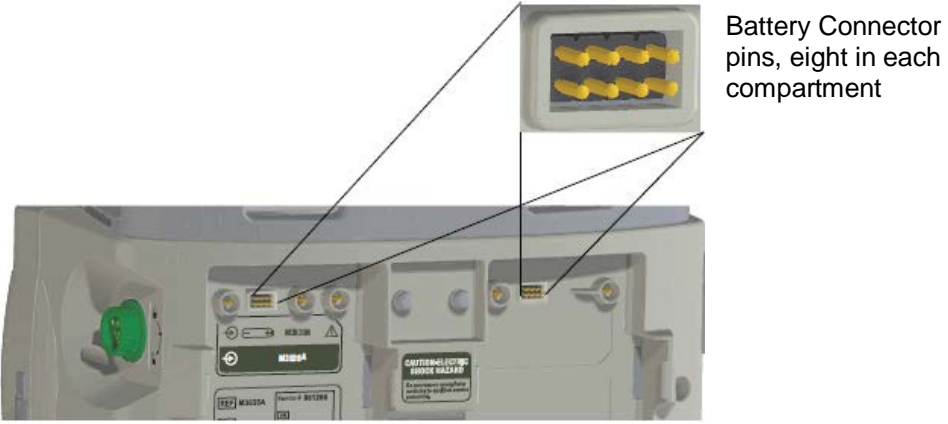
<b>BEHAVIOR DESCRIPTION 1</b>	<p>If the battery connecting pins (in the battery compartment of the HeartStart MRx Monitor/Defibrillator) become damaged or contaminated, it could result in a poor electrical connection that may cause the MRx to either (i) not power on or (ii) repetitively reboot, when used on battery power only.</p>
<b>HAZARD INVOLVED 1</b>	<p>HeartStart MRx Monitor/Defibrillator may, on exceptionally rare occasions, either (i) not power on or (ii) repetitively reboot. Either situation would make the device inoperative, delaying therapy to a patient in need of defibrillation, cardioversion, pacing, or monitoring.</p>
<b>ACTION TO BE TAKEN BY CUSTOMER / USER – 1</b>	<p>When inspecting the device, inspect the HeartStart MRx battery compartment connections. Include this step as part of a routine Operational Check to verify that the battery connector pins are clean, fully extended, not bent, and without residue.</p> <p><b>Figure A: Battery Connector Pins</b></p>

<p>Battery Connector pins, eight in each compartment</p>

<b>ACTIONS PLANNED BY PHILIPS - 1</b>	<p>Philips is voluntarily initiating this correction and is providing an Instructions for Use (IFU) Addendum entitled, <u>HeartStart MRx Battery Connector Pins</u>, for all customers with affected units.</p>

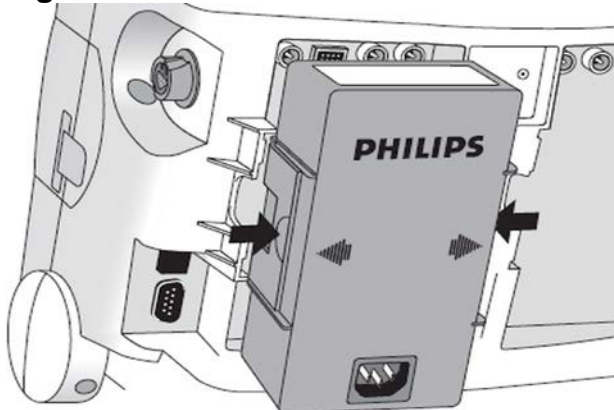
**Figure C: AC Module Removal**

- a. Remove the AC module from the MRx, rather than unplugging the cord from AC mains (see Figure C).

There are two ways to prevent this power switching. The user can either:

<p>b. Turn on the MRx using the rotary knob and allow it to complete the start-up before unplugging the device from AC mains.</p> <p>Philips also reminds you to keep batteries fully charged before use, as per the instructions in the HeartStart MRx Monitor/Defibrillator Instructions for Use (IFU).</p>
<b>ACTIONS PLANNED BY PHILIPS - 2</b>	<p>Philips is voluntarily initiating this correction and is providing measures to prevent, or methods to allow the user to correct, the abnormal device behavior related to charging and pacing after disconnecting the device from AC mains.</p> <p>Philips is evaluating both software and hardware changes to prevent this abnormal device behavior. Once the solution is available, you will be contacted by Philips if you have a device that is at risk of exhibiting this issue.</p>
