FIELD CORRECTIVE ACTION NOTICE

13 August 2018

The purpose of this letter is to advise you that Medtronic is issuing a voluntary field correction **to revise the replacement instructions for the Li-ion battery packs used in BIS™ Vista and BIS™ View Monitoring Systems.**

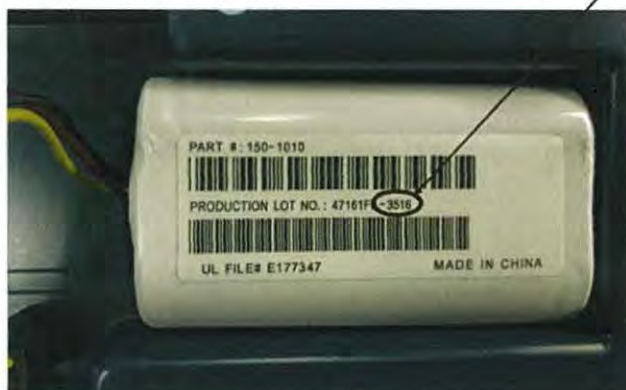
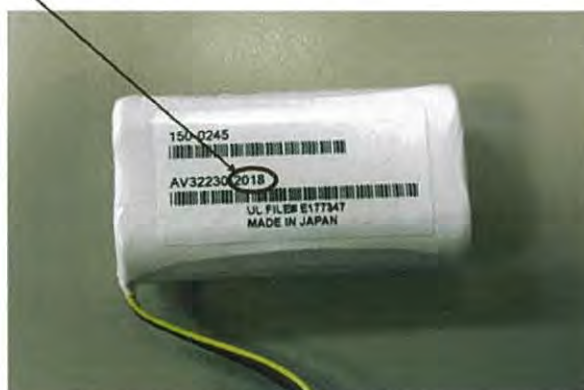
Manufacture date (WWYY)

- The battery pack is located at the rear of the monitor
- To inspect the battery, you will need a Philips #2 screwdriver. Follow the 4 steps below to access and identify the age of the battery pack:
 - Unplug A/C line cord from the monitor.
 - Lay monitor screen-side-down on a smooth work surface so that the Battery/Power Supply cover is accessible. If necessary, protect display screen from being scratched by the work surface.
 - Remove 4 screws from the Battery/Power Supply cover using a Philips #2 screwdriver and remove the cover.
 - The battery manufacture date (in the form WWYY) can be found on a white label on the back of the battery pack. See photo below for details on how to locate the manufacture date.

- Batteries with date code 3114 or older (Week 31 of 2014) exceed 4 years of age and should be removed from the monitor and disposed of according to your facility's standard process.
- Batteries that are more than two years old and less than four years old (Date codes ranging from 3114 to 3016) should be tested as described below.
- Batteries with date code 3116 or newer (Week 31 of 2016 to present) are confirmed to be conforming and not affected by this issue.

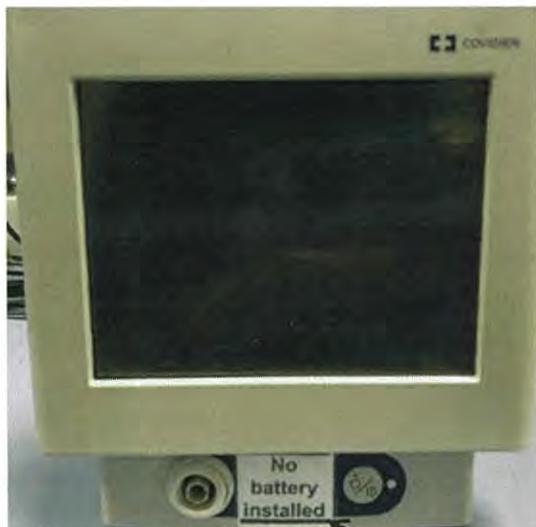
BIS™ Vista Monitoring System

- Included with this notification are stickers to be placed on BIS™ monitors when the battery pack is removed
- The stickers should be placed on the monitors as shown below.

- The monitor must have the “No Battery Installed” label applied to the front bezel.
- The monitor will not function if it is not connected to AC power; therefore, it cannot be used for transport of patients, or other instances where it is necessary to operate it without connection to AC power.
