URGENT – FIELD SAFETY NOTICE

Concerto & Basic shower trolley

Date:	2020-JAN-08
Product Issue:	Concerto & Basic shower trolley – Potential unintentional drop of safety side panel
Affected Product:	✓ Concerto & Basic shower trolleys manufactured between 2018-Oct-19 and 2018-Nov-07 Serial number ranges: P0513634 and P0515600
Affected Serial No.:	Attachment 3a rev. 2
Resolution:	Safety catches replacement in order to ensure the device is operating safely
Field Safety Notice:	FSN-POZ-002-2019 rev. 2
Pages:	3 & Customer Response Form

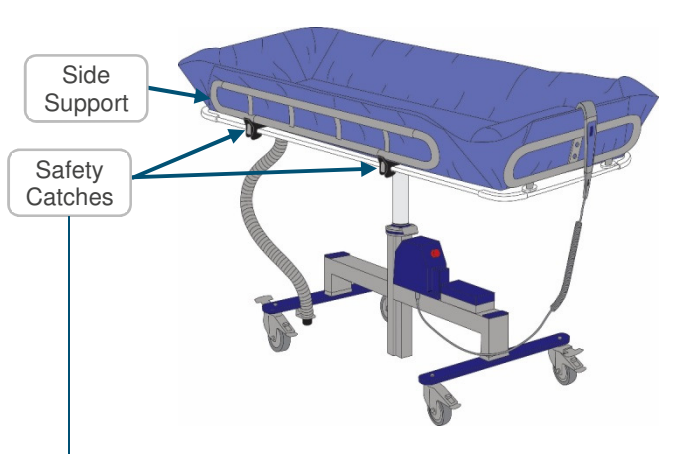
Image 1

Each Concerto & Basic shower trolley is equipped with two Side Supports, one on each side of the shower trolley (Image 1). Each side support is secured by two (2) Safety Catches (Image 2) which are used to fold down the supports as well as secure the support in the raised position.

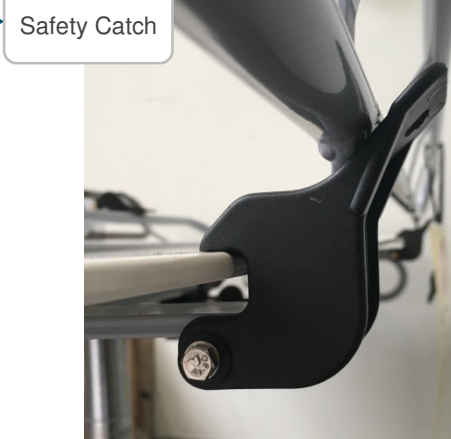
Image 2

Arjo has become aware that there is likelihood that any of the 4 Safety Catch(es) may exhibit a mechanical failure (break in one of the arms of Safety Catch), which in certain circumstances may contribute to the Side Support unintentionally opening and may lead to a potential risk of patient fall, leading to possible injuries to patient and/or caregiver.

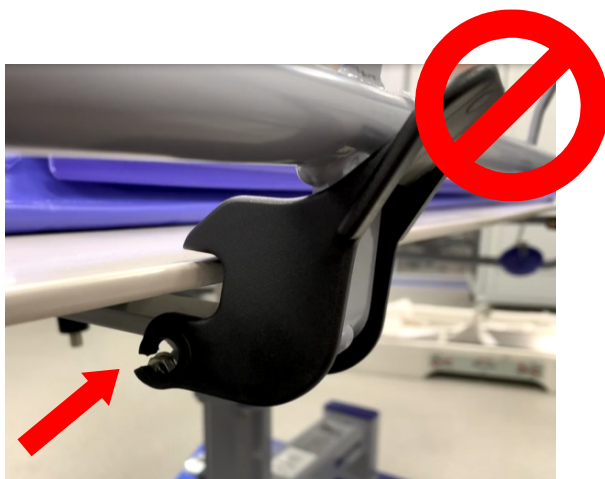
Image 3

1. Verify the condition of all 4 Safety Catches attached to your device. If you notice the break (as shown in Image 3) withdraw the trolley from use.

- ✓ It is recommended that the Safety Catches on the shower trolley Side Supports be inspected daily to ensure any of the catches are not broken as show on the Image 3.
- ✓ The patient is not left unattended at any time.
- ✓ The patient is fully assisted so that he/she does not grab, push or lean against the Side Supports during showering activities.
- ✓ Caregivers should limit pulling and pushing of the Side Supports with excessive force.
- ✓ **Note:** always adhere to the Safe Working Load as outlined in the IFU.
