URGENT - FIELD SAFETY NOTICE

**GETINGE VOLISTA StandOP and TRIOP
Field Action MSA-2017-001-IU**

Product Issue: Potential keypad failure on VOLISTA StandOP and TRIOP Surgical Lights

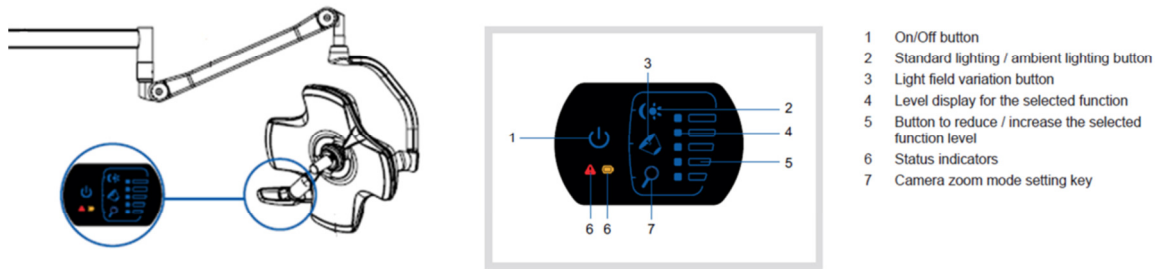
The issue we found can cause a failure of the control keypad. This can result in the cupola not turning on or off. We have received numerous complaints where this problem happened on 3 different keypad versions. From our investigation which includes our evaluation of worst-case scenarios it was concluded that there is only a remote chance that the problem may cause injury. However it is possible.

This potential for malfunction is caused by an internal frequency issue of a component on keypads version 1, and by the touch-sensitive technology that was not sensitive enough on versions 2 and 3. The keypads at fault are no longer produced. We have implemented a more robust keypad using a different technology. Although the probability of occurrence of harm is low, we want to prevent any related event from occurring with our customers.

Resolution: Maquet SAS proposes to replace the keypads ARD568801560 on the devices with keypads of a different design ARD568805501 to make sure all devices present in the market are working effectively and safely

This action is to replace the potentially defective keypads with the new ones. The devices involved at your facility are listed in the consignee list file you received for this field action.
